# Manhole Inspection Summary

Manhole # S69U\_\_015MH

Insp Date: **5/21/08 2:43 PM**

**Location** Address: **1725 Malvern St.**

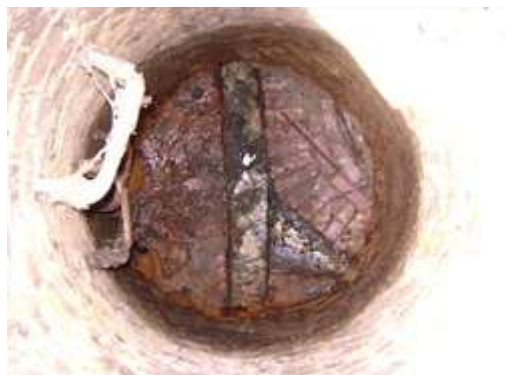
Top View

Comments **DEBRIS IN CHANNEL.**

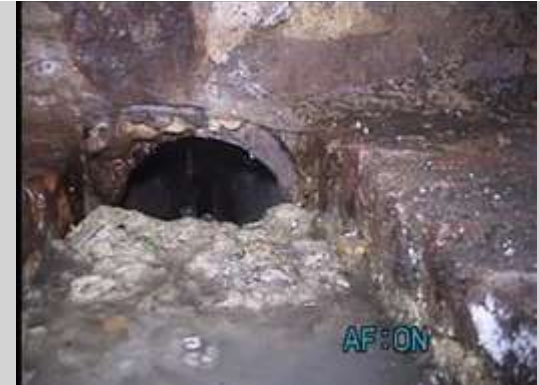
12 O'Clock Outflow

Pipe Height: **8.4** (in.) Rod and Bar (Angled)  
Pipe Material: **Clay** ☐ Pipe Lined  
Invert Depth: **9.67** (ft.) Flow Characteristics: **Slow**  
Deposits: ☒ None ☐ Mud ☐ ~~Gravy~~ ☐ Debris ☐ Grease  
Silt Depth: (in.) Deposits Extent:  
Infiltration: **None** Pipe Seal Cond: **Sound**
